Oilheating

February 2003

Causes of soot damage to residential structures

By John Certuse P.E.

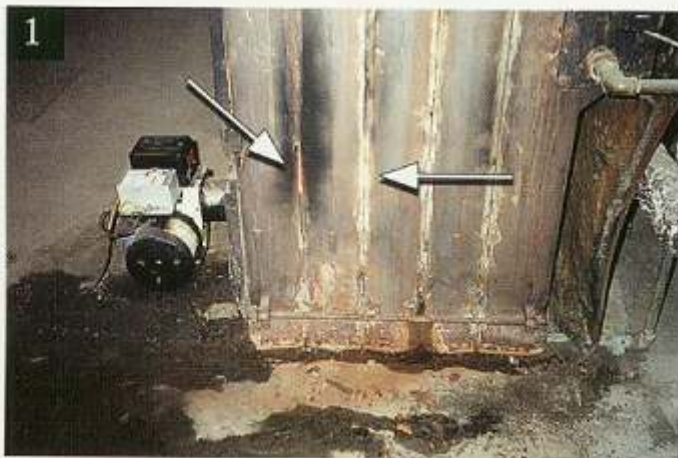
Photo 1: These boiler sections are leaking products of combustion into the structure. The rope packing between the sections has deteriorated, allowing slow entry of soot products into the structure directly from the appliance.

Some boilers and furnaces do leak and allow emission entry into the interior of the structure directly. Typically, this is caused by maintenance and age/wear and tear issues of the boiler or furnace*. Some examples of these conditions are shown in photos 1-4.

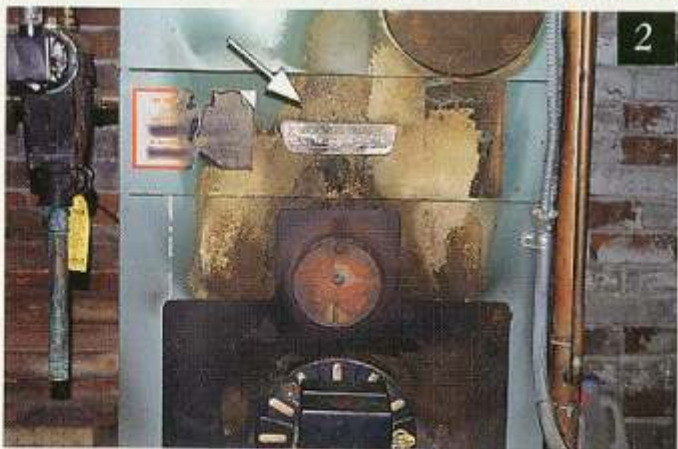
Photo 2: Poor cleaning and poor draft caused the plugged firesides of this boiler. Products of combustion cannot pass through the appliance and are forced back out into the structure. This is known as backpressure.

Soot damage to homes is also commonly encountered by service technicians as a result of a plugged boiler or furnace heat exchanger. This can result in a reversal in flow direction, causing the appliance to "leak" large amounts of combustion products from openings such as combustion chamber observation doors and gasket areas on the firesides of the appliance.

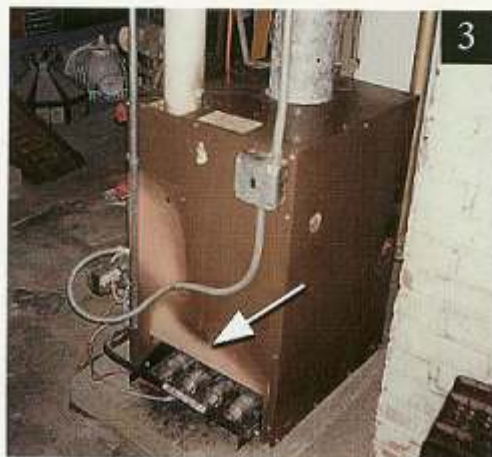
Photo 3: A poor draft can also cause products of combustion to reverse flow and enter the structure. Again, products of combustion cannot pass through the appliance and are pushed back out into the structure. This is called rollout in gas fired appliances.

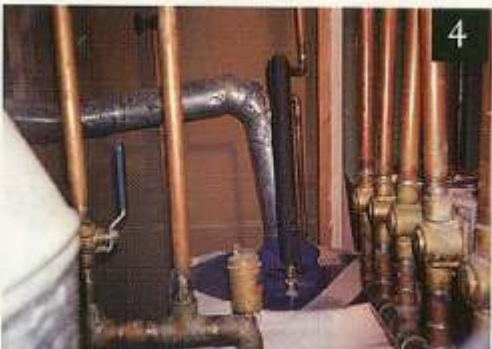
Photo 4: Stovepipe pitch should be upward towards the chimney at a slope of 1/4 inch per horizontal foot—not as shown here. Upon the burner's shutting down, emissions in the piping may re-enter the structure.

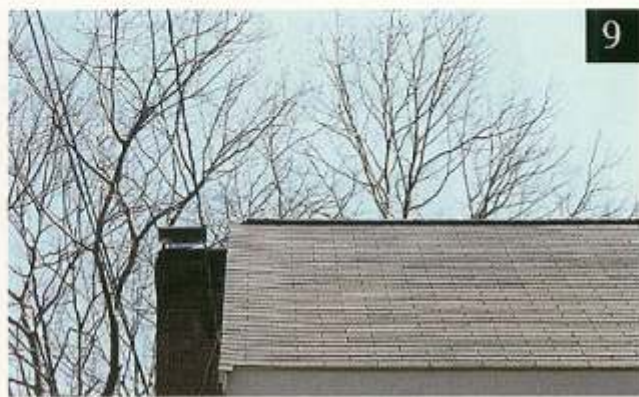
Photo 9: This chimney is below the peak of the structure. Discharge of gases should be at least two feet above the structure (see text) to prevent their re-entering the building.

These guidelines recommend that discharge gases be discharged above the eddy zone, and if possible, above the wake zone, which is generally two feet above the peak of a structure. Photo 9 shows an arrangement that would be inappropriate under these guidelines.

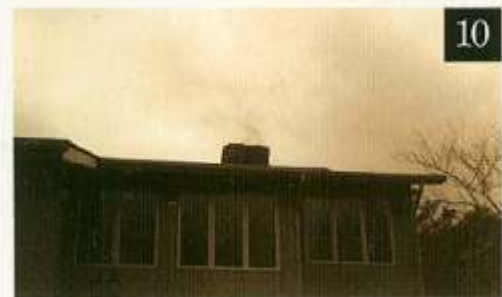
Photo 10: Malfunctioning burner's smoke lies closer to the house structure due to decreased stack effect. ©ISE

This failure causes heavier products of combustion, which cannot exit the chimney with the same velocity and hence distance themselves from the house as quickly as those from a properly firing burner. The force a chimney develops is known as the *Stack Effect*.

The Stack Effect is the pressure difference caused by the difference in air and flue gas densities. The value of the Stack Effect directly correlates to the burner gases' ability to exit the chimney with an acceptable velocity and the discharge distance from the structure.

Poor combustion will also affect the plume characteristics emitting from a chimney if the burner is running poorly. This results in a decreased stack effect that will alter the discharge point of emissions from a chimney, increasing the likelihood of re-entry with infiltration air.
